81031718

Guidance notes for drilling missing holes on VW T5/T6

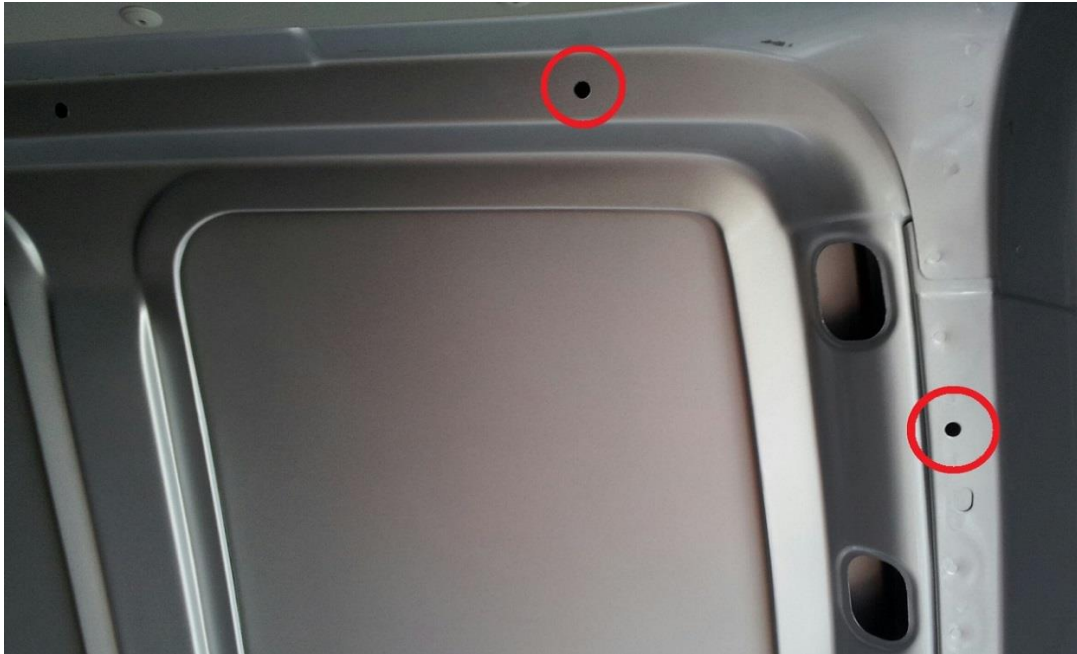
Please note, on some VW T5/T6 panel vans manufactured in Poland (chassis build code X) the holes for the rear upper side lining panels maybe missing, two of these are used to fit the top rear fixing brackets of the modulo van racking.

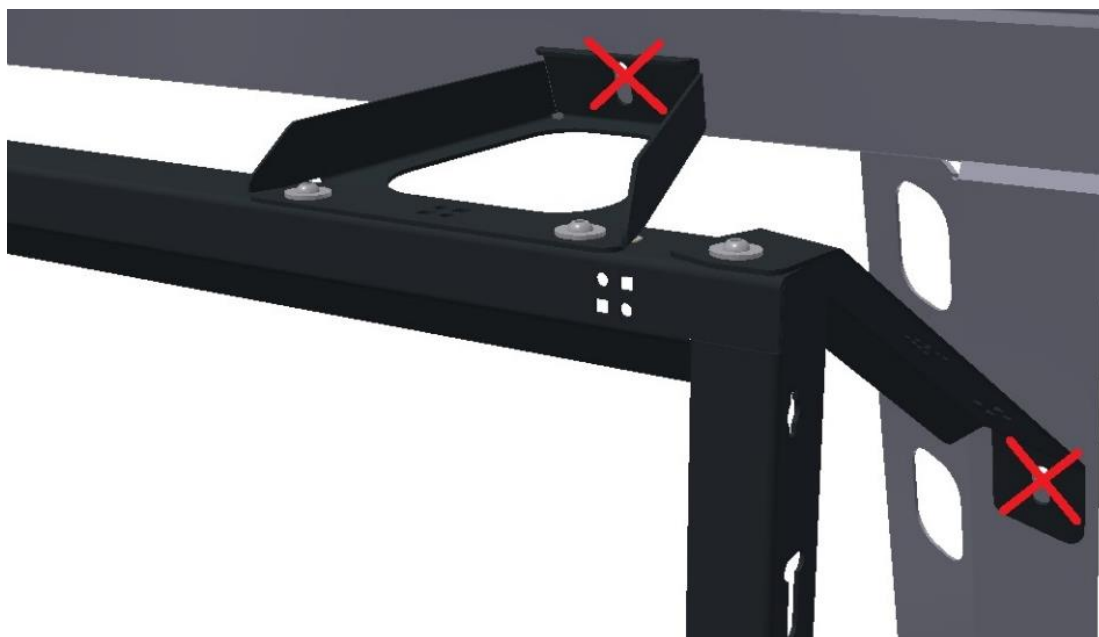
Step 1

Fit the rear frame and brackets as per the main installation instructions then mark the two missing holes through the bracket holes using a marker pen or centre punch.

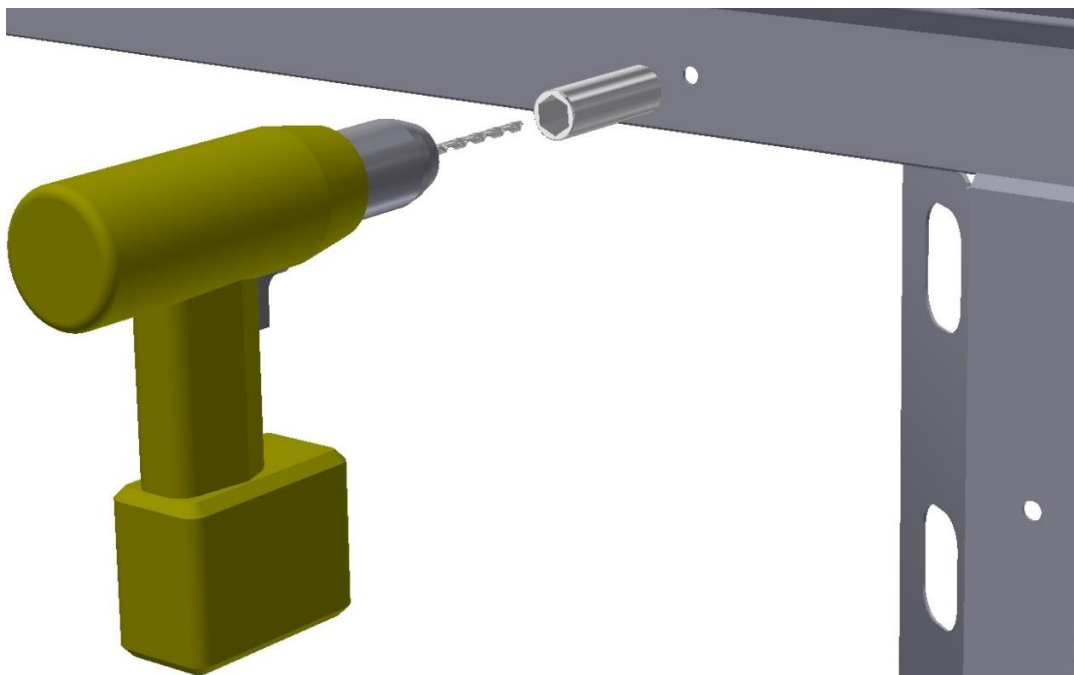
Step 3

Taking care not to damage the outer panel of the van, drill the holes starting with a small diameter drill bit, then finally a 9mm drill bit.

Important; use a suitably sized sleeve or deep socket over the drill bit to limit the drilling depth preventing damage to the outer panel of the van.
